Manhole Inspection Summary

Manhole # S15MM1018MH

Location Address: **4701 GREENSPRING AVE**

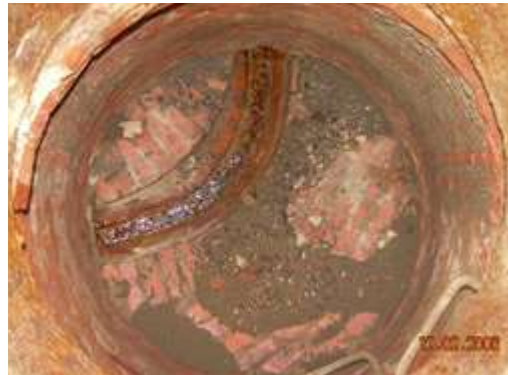
Top View

Evidence of surcharge - Bench debris.

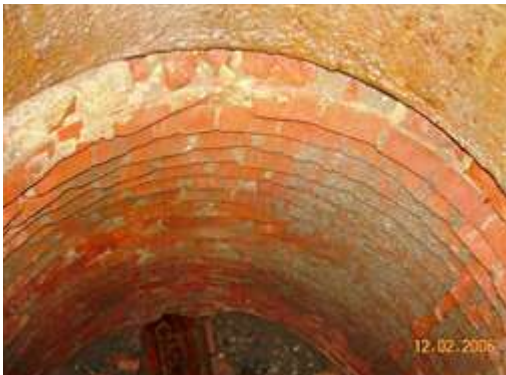
Defect

Frame leaks. Adjustment deterioration and infiltration. Corbel and Barrel infiltration.

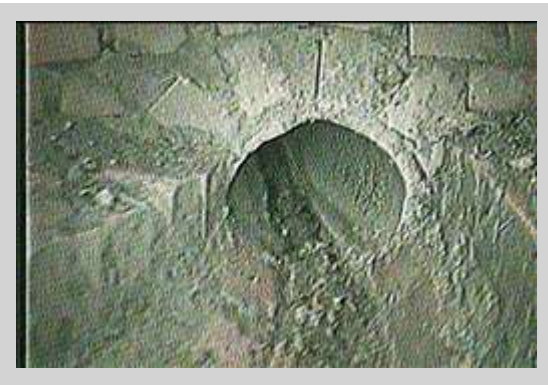
8 in. Circular Gravity Sewer Pipe Out @ 12 O'Clock

Barrel deterioration and infiltration.

Deposits: ☐ None ☒ **Mud** ☒ **Gravy** ☒ **Debris** ☐ Grease

Silt Depth: **0.5** (in.) Deposits Extent: **Light**

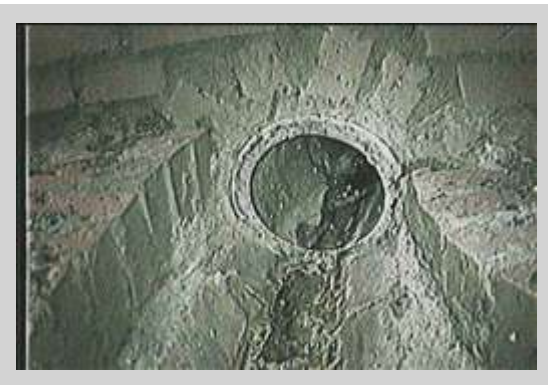
6 in. Circular Gravity Sewer Pipe In @ 8 O'Clock

Channel deterioration.

Deposits: ☐ None ☒ **Mud** ☒ **Gravy** ☒ **Debris** ☐ Grease

Infiltration: **Evidence** Pipe Seal Cond: **Unknown**
